Hippodrome Brighton

Preservation & Roofworks Application

March 2021

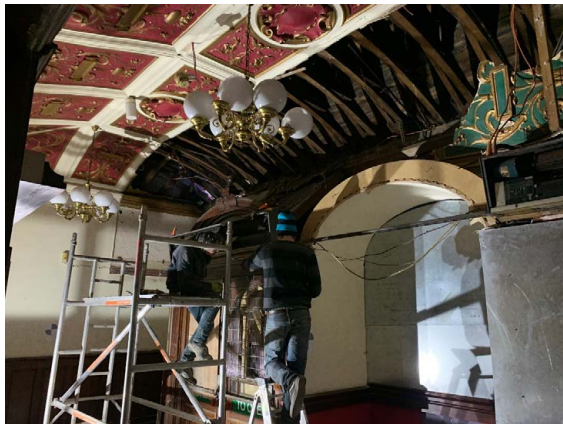
Vaulted ceiling and door surrounds exposed after removal of studwork

An initial section of restoration work has been started at the main entrance lobby of the Brighton Hippodrome. The original curved Matcham ceiling soffit was partially concealed to accommodate mechanical ventilation for the buildings conversion to a Mecca Bingo hall in the 1960's. This has been removed to expose the original timber ceiling battens. Identical replacement ceiling panels are currently being constructed to help transform this room back to its former condition.

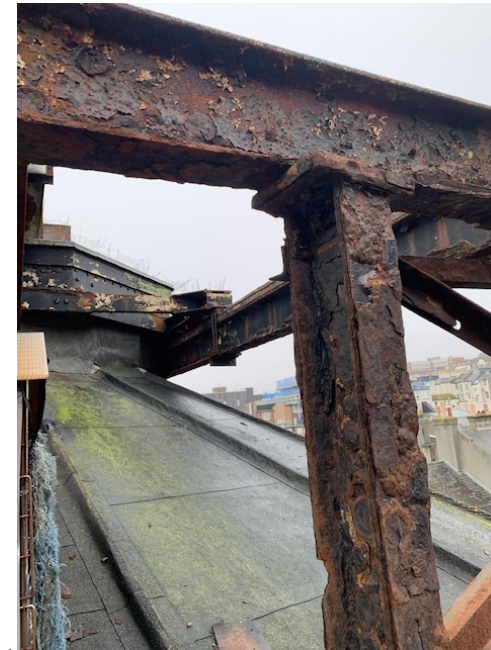
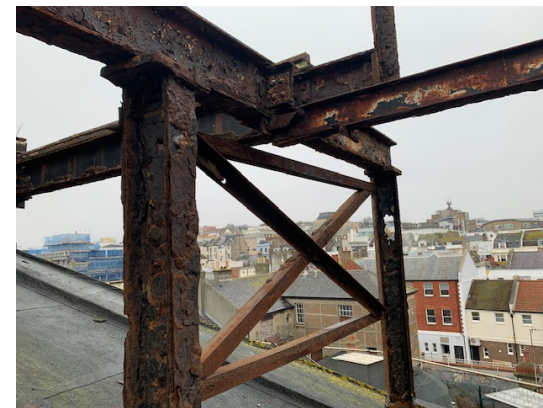
Photographs showing condition of steelwork in structure proposed for removal.
